July 30, 2018

VASA AND PROJECT MANAGEMENT

**Tony Yep, P. Eng
Drygon Consulting Inc.**

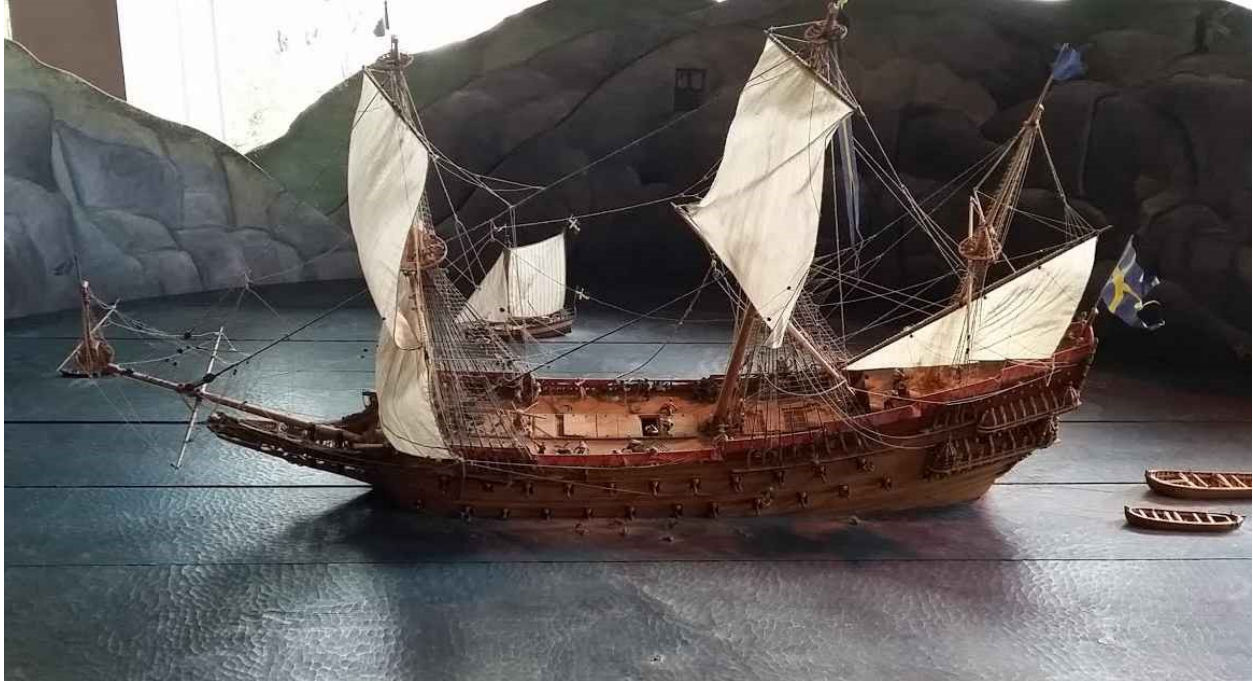
FIGURE 1 – EXHIBIT AT VASA MUSEUM

There is an exhibit at the Vasa Museum which shows an exact replica of the Vasa just prior to its infamous sinking. The ship had 48 large 24 lbs. cannons - 24 on the lower gun deck, 22 on the upper gun deck, and one cannon each at its bow and stern. This was lower than the initial 60 cannons wanted by the King due to delivery problems from the foundry.

The Vasa is shown heeling to port under a slight breeze from the right. Only four of its ten sails were unfurled. The ship was already sitting fairly low to the waterline and the cannon port holes were opened as it was intended to fire a full cannon salute when the ship left the harbour. The ship was so unstable that even with the light breeze, it tipped over so quickly that the captain could not release the sails or close the open cannon port holes in time. The water rushed in through the open port holes on the lower gun-deck and flooded the ship.

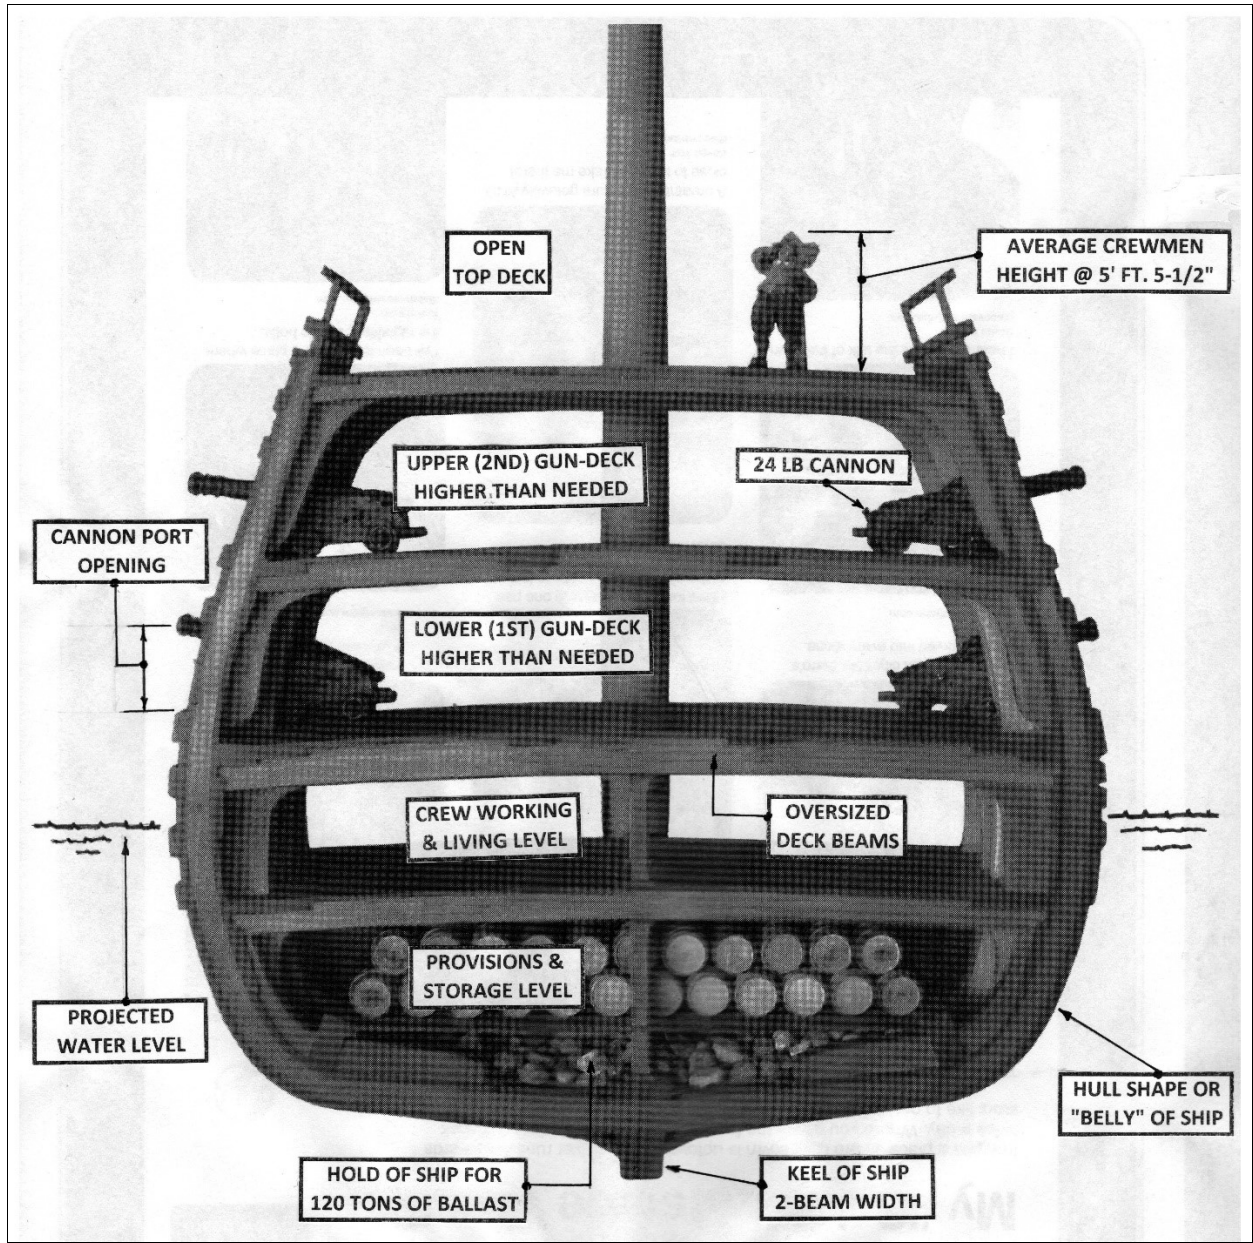
FIGURE 2 - CROSS-SECTION OF THE VASA

- The ship was already sitting low on the water line very close to the cannon port hole openings on the lower gun deck level. Modern calculations confirmed that the ship was so unstable that it would have heeled over at a list of only 10 degrees and that it would not have withstood a light breeze of only 4 knots (about 4.5 mph). [2]
- The compartment for the ballast was completely filled, yet more ballast was needed. Modern calculations have indicated that another 120 tons of ballast was needed to keep the ship stable. The extra ballast could have been added to the bottom deck level where the ship and crew's provisions were to be stored. But doing so would weigh the ship down and put the lower gun deck level below the water line.

- There was much more of the ship's structure above the water line than the portion sitting below the water level. The addition of the second gun deck level made the ship tall, narrow and top heavy with a high center of gravity.

- The structure for the gun deck levels were over designed and the supporting beams for these decks were much larger and heavier than they needed to be for the cannons the Vasa was to carry. The height of the two gun deck levels were also about one foot higher than all the other decks. The typical height of crew members was about 5'-5-1/2" and the lower deck where the crew members lived was much lower in height and the supporting beams were much smaller as compared with the two gun deck levels above. This extra height and weight contributed to the ship's instability.

- The ship was asymmetrical with a tendency to lean towards the port (left) side. Unballasted, the ship would be inclined to lean to port. ^[4] This was due to two different crews of carpenters working on each side of the ship and using different measurement rulers. This wasn't a major problem if this fact were known as the ballast and other loads could have been re-distributed to keep the ship balanced and centered.
